HAMPDEN COUNTY REGISTRY OF DEEDS

DAMS FILE COLLECTION

BOOK D25 – 4 (U-Z)

Reports Section—Dams - Hampden County Massachusetts

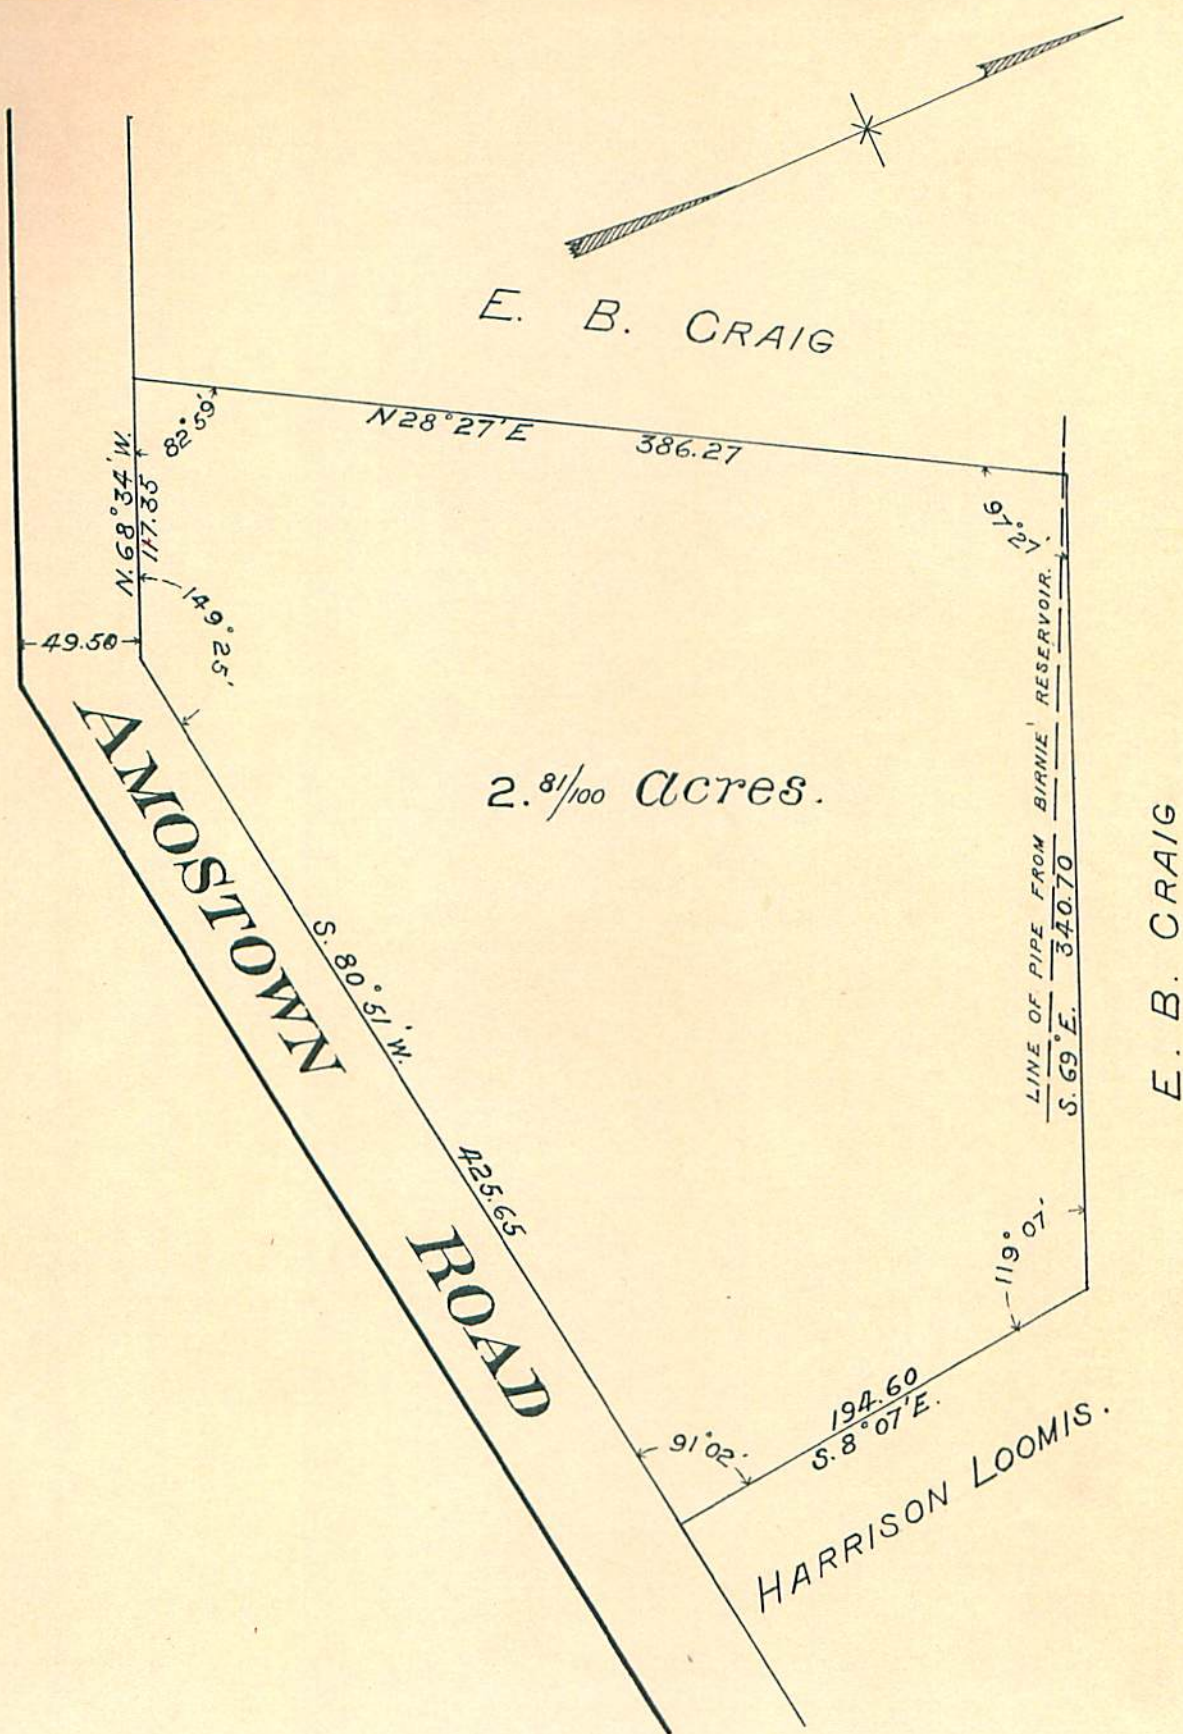
3

PLAN OF LAND
TAKEN FROM
E. B. CRAIG
GEO. N. MERRILL C.E.
SCALE 1 INCH = 80 FEET
OCT. 1893.

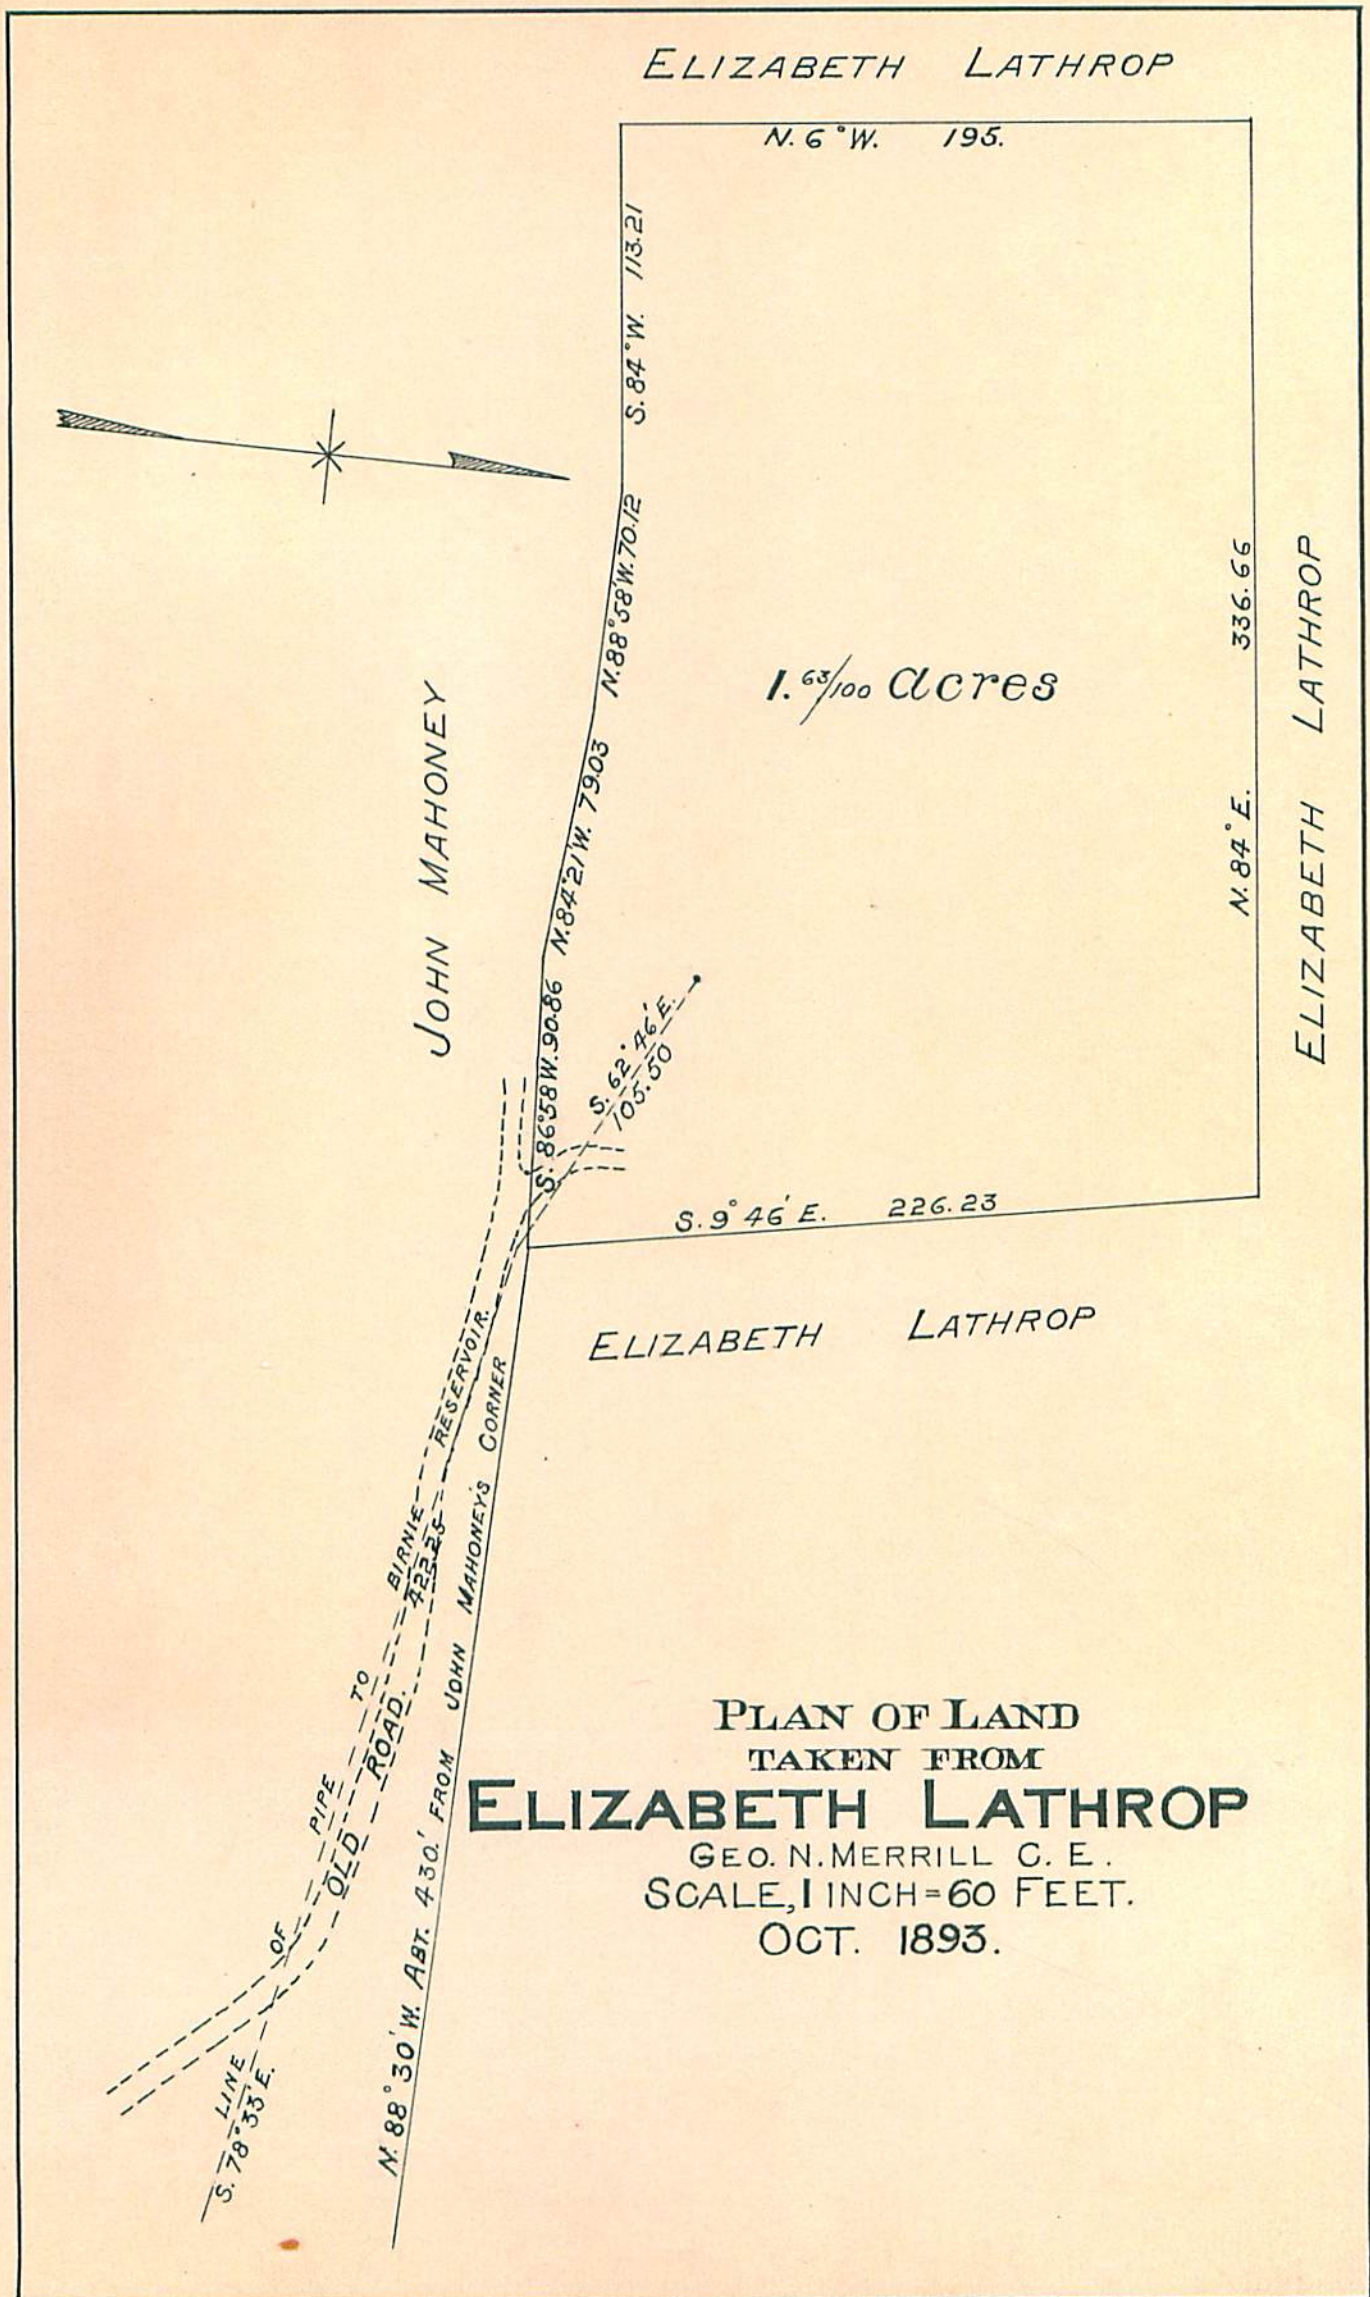
5

PLAN OF LAND
TAKEN FROM
ELIZABETH LATHROP
GEO. N. MERRILL C. E.
SCALE, 1 INCH = 60 FEET.
OCT. 1893.

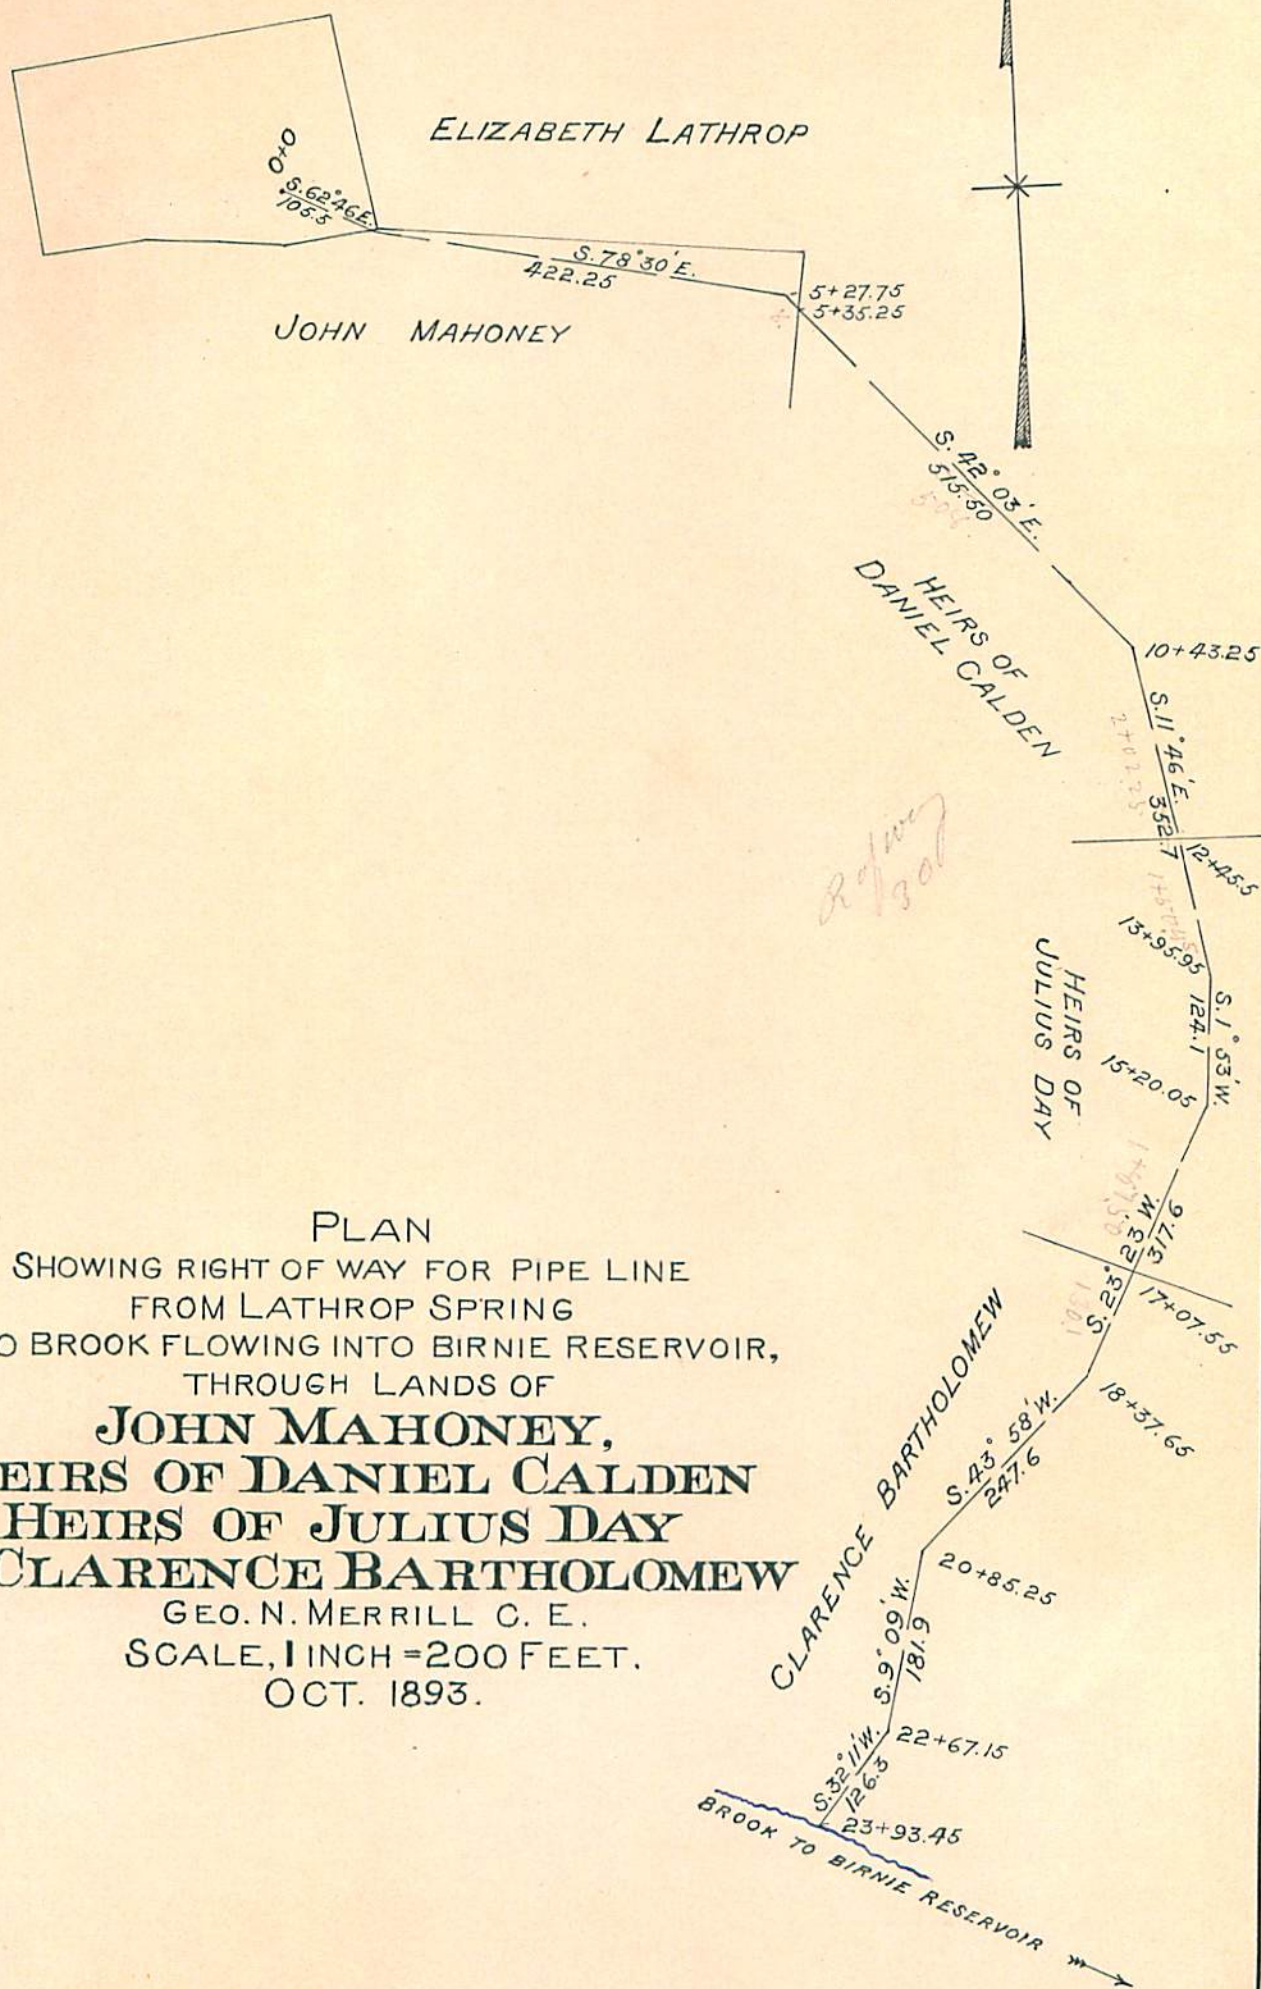
7

PLAN
 SHOWING RIGHT OF WAY FOR PIPE LINE
 FROM LATHROP SPRING
 TO BROOK FLOWING INTO BIRNIE RESERVOIR,
 THROUGH LANDS OF
JOHN MAHONEY,
HEIRS OF DANIEL CALDEN
HEIRS OF JULIUS DAY
& CLARENCE BARTHOLOMEW
 GEO. N. MERRILL C. E.
 SCALE, 1 INCH = 200 FEET.
 OCT. 1893.

The Town of West Springfield, acting by its Board of Water Commissioners, have taken, and do hereby take the right of way over the herein described lands situated in the Town of West Springfield, to wit,- a certain piece or strip of land 30 ft. wide, extending from land taken from Elizabeth Lathrop, easterly and southerly through land of Elizabeth Lathrop, John Mahoney, Heirs of Daniel Calden, Heirs of Julius Day, and of Clarence Bartholomew, to a brook leading to Birnie Reservoir,- meaning and intending to take a Right of Way to lay and forever maintain a line or lines of pipe for the purpose of conveying water from the land taken of Elizabeth Lathrop, to the brook flowing into Birnie Reservoir, over any or all lands lying within 15 ft. on either side of a centre line of location, which centre line is located and defined as follows, to wit;-

Beginning at a station 1+05.5 as shown on the annexed plan, near the southeast corner of the land taken from Elizabeth Lathrop; thence S 78 degrees 30' E 422.25 ft. on land of John Mahoney and Elizabeth Lathrop; thence S 42 degrees 3' E 8.5 ft. to the division line between land of John Mahoney and land of the Heirs of Daniel Calden; thence in the same course 508 ft. to an angle; thence S 11 degrees 46' E 222.05 ft. to the division line between land of the Heirs of Daniel Calden and land of the Heirs of Julius Day; thence on the same course (S 11 degrees 46' E) 150.45 ft. to an angle; thence S 1 degree 53' W 124.1 ft. to an angle; thence S 23 degrees 23' W 187.5 ft. to the division line between land of the Heirs of Julius Day and land of Clarence Bartholomew; thence in the same course (S 23 degrees 23' W) 130.1 ft. to an angle; thence S 43 degrees 58' W 247.6 ft. to an angle; thence S 9 degrees 09' W 181.9 ft. to an angle; thence S 32 degrees 11' W 126.3 ft. to the brook before mentioned.

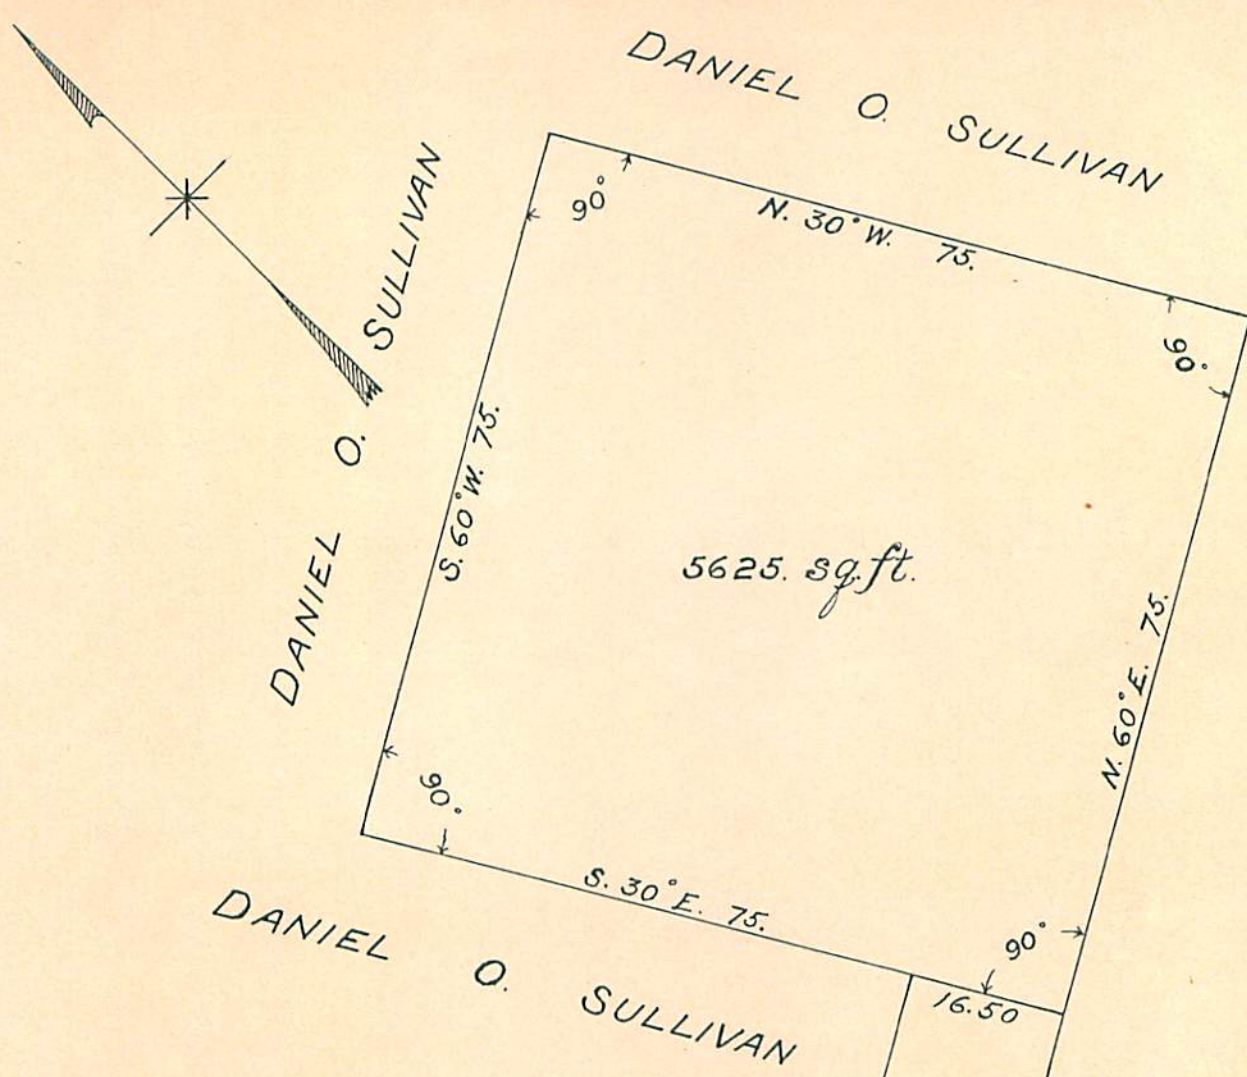
PLAN OF LAND
TAKEN FROM
DANIEL O. SULLIVAN
GEO. N. MERRILL C.E.
SCALE, 1 INCH=20 FT.
OCT. 1893.

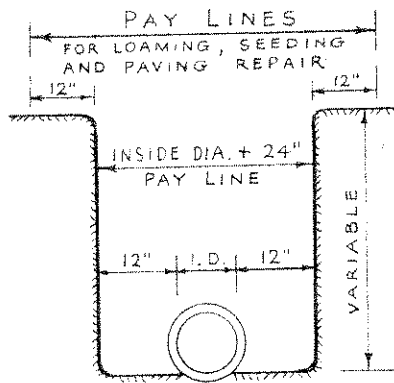
EARTH EXCAVATION
PIPE TRENCH

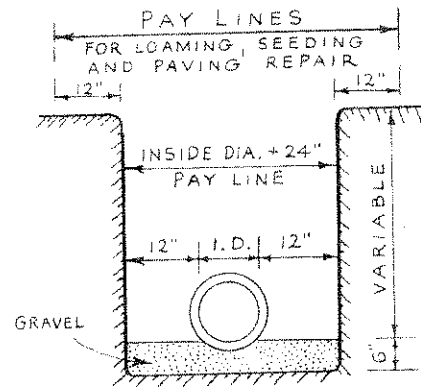
ROCK EXCAVATION
PIPE TRENCH

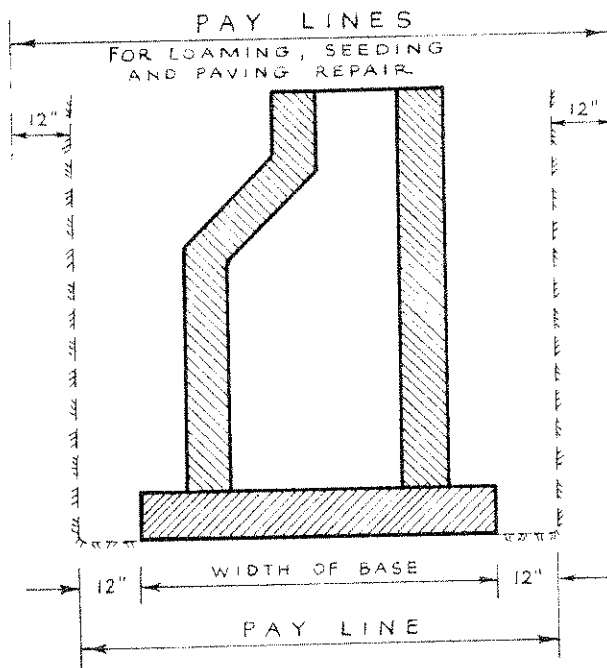
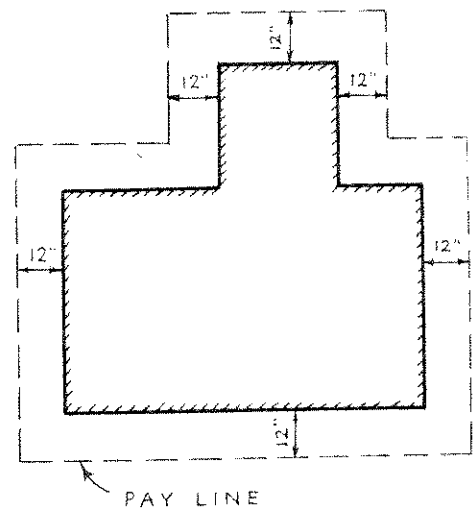
SECTION

PLAN

EXCAVATION FOR STRUCTURES

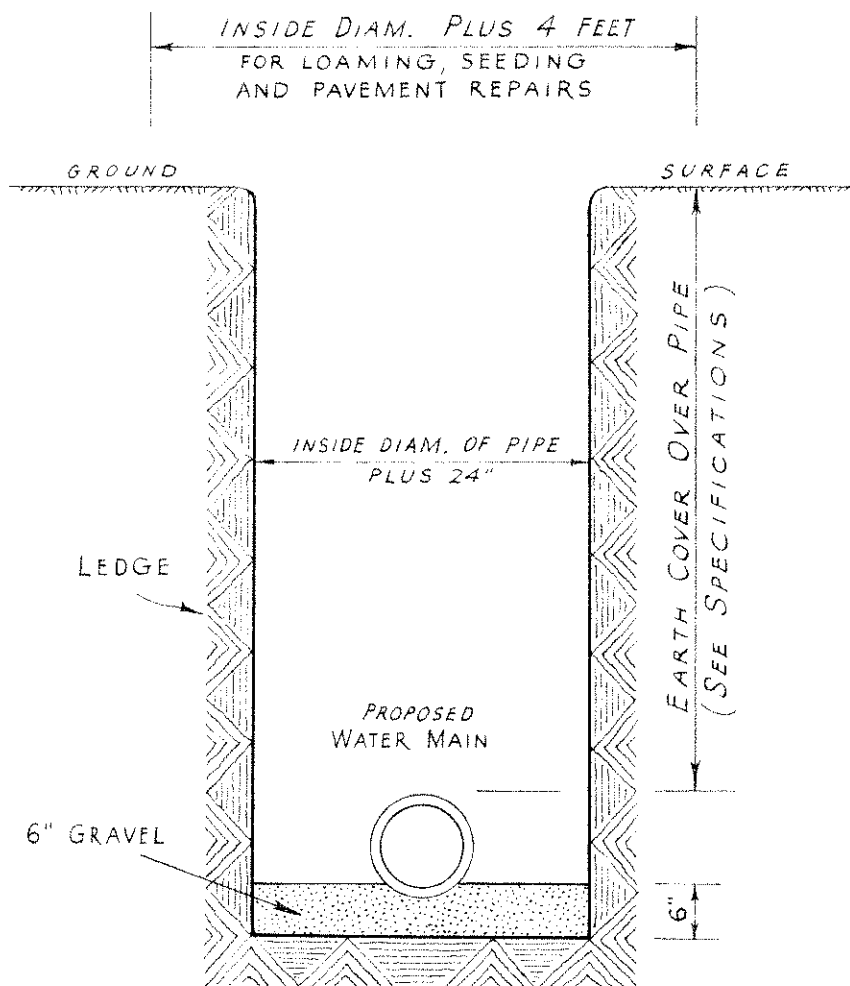
CONTRACTOR WILL BE PAID ONLY FOR
ACTUAL DEPTH OF LEDGE EXCAVATED IN
 CASES WHERE LEDGE IS OVERBURDENED
 BY AN EARTH COVER.

STANDARD DETAIL
 PAY LINES FOR ROCK SECTION,
 PAVING AND LOAMING, ETC.

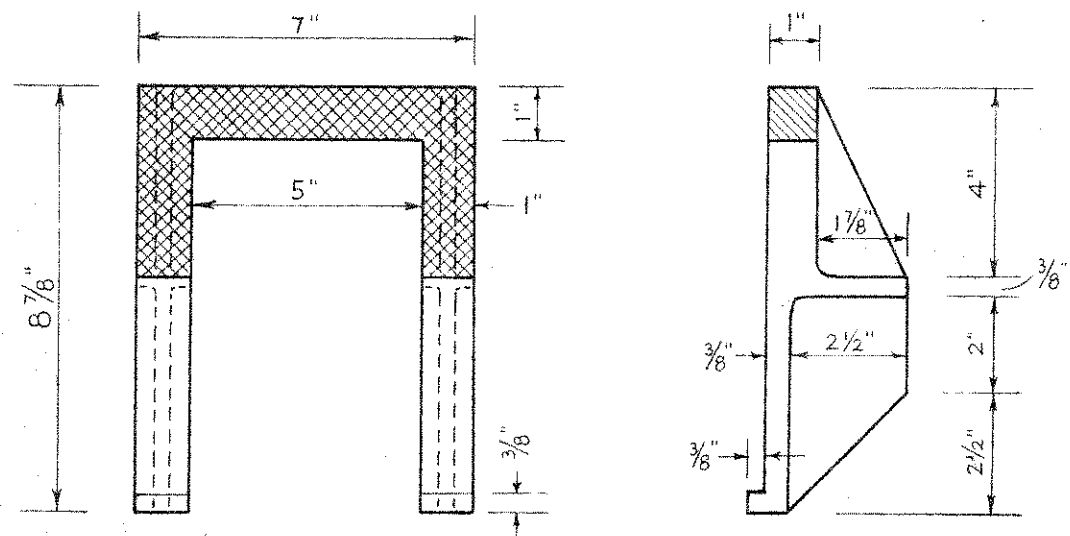
ALL MANHOLE STEPS TO BE CAST IRON,
WEIGHT APPROXIMATELY 10⁰⁰.

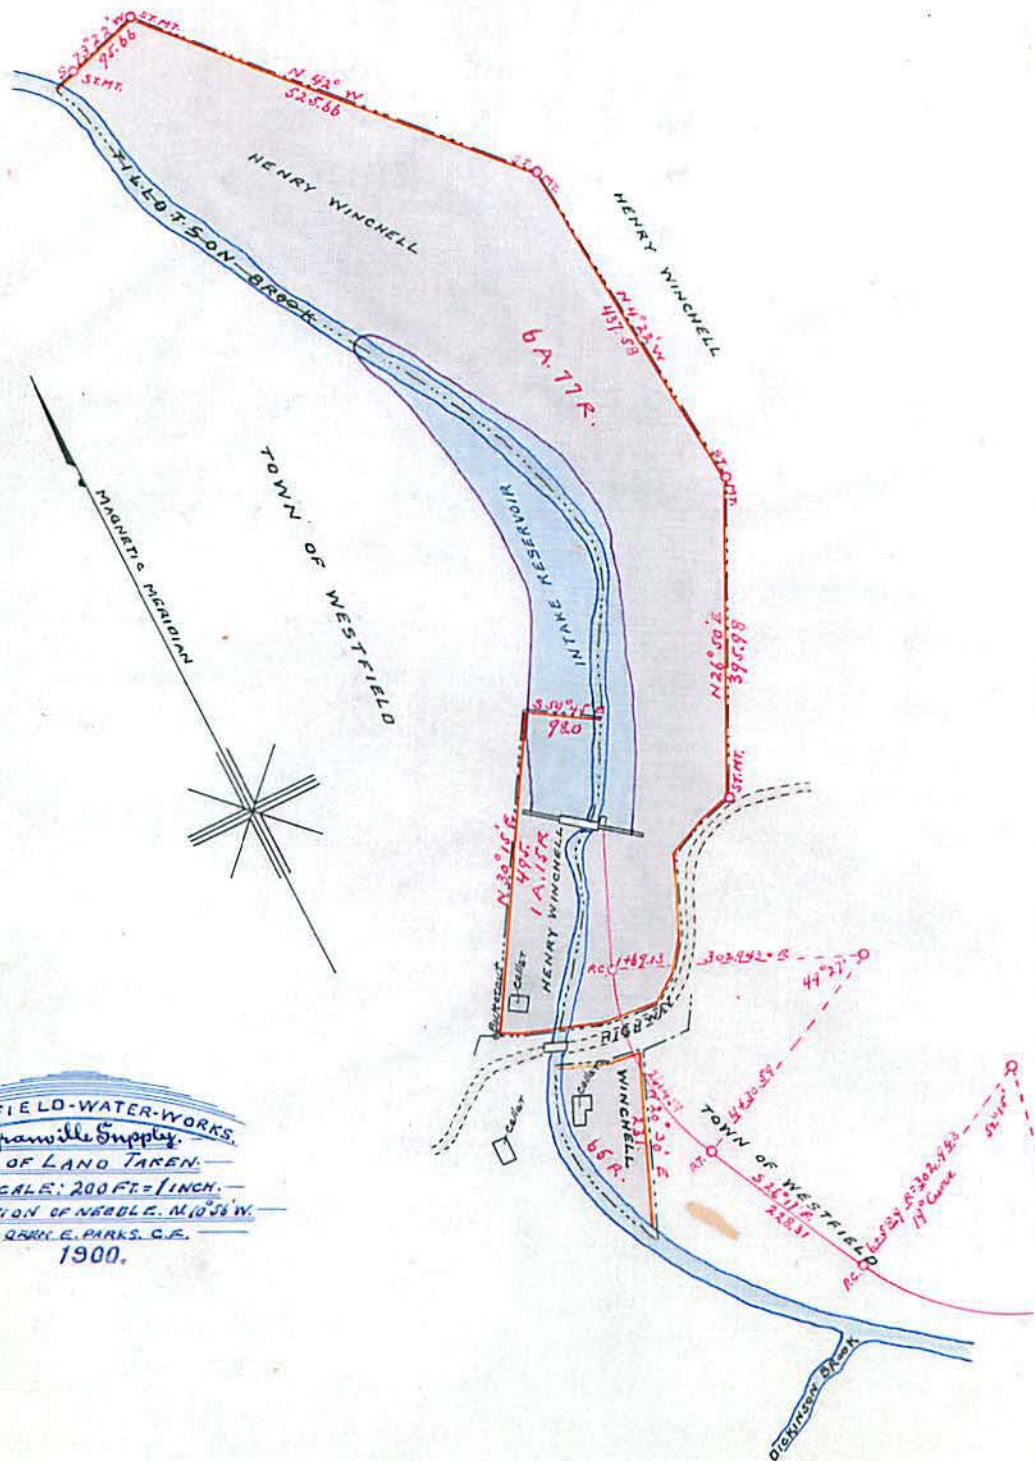
WESTFIELD-WATER-WORKS.
 Granville Supply.
 MAP OF LAND TAKEN.
 SCALE: 200 FEET = 1 INCH.
 VARIATION OF NEEDLE, N. 10° 38' W.
 J. E. PARKS, C.E.
 1900.

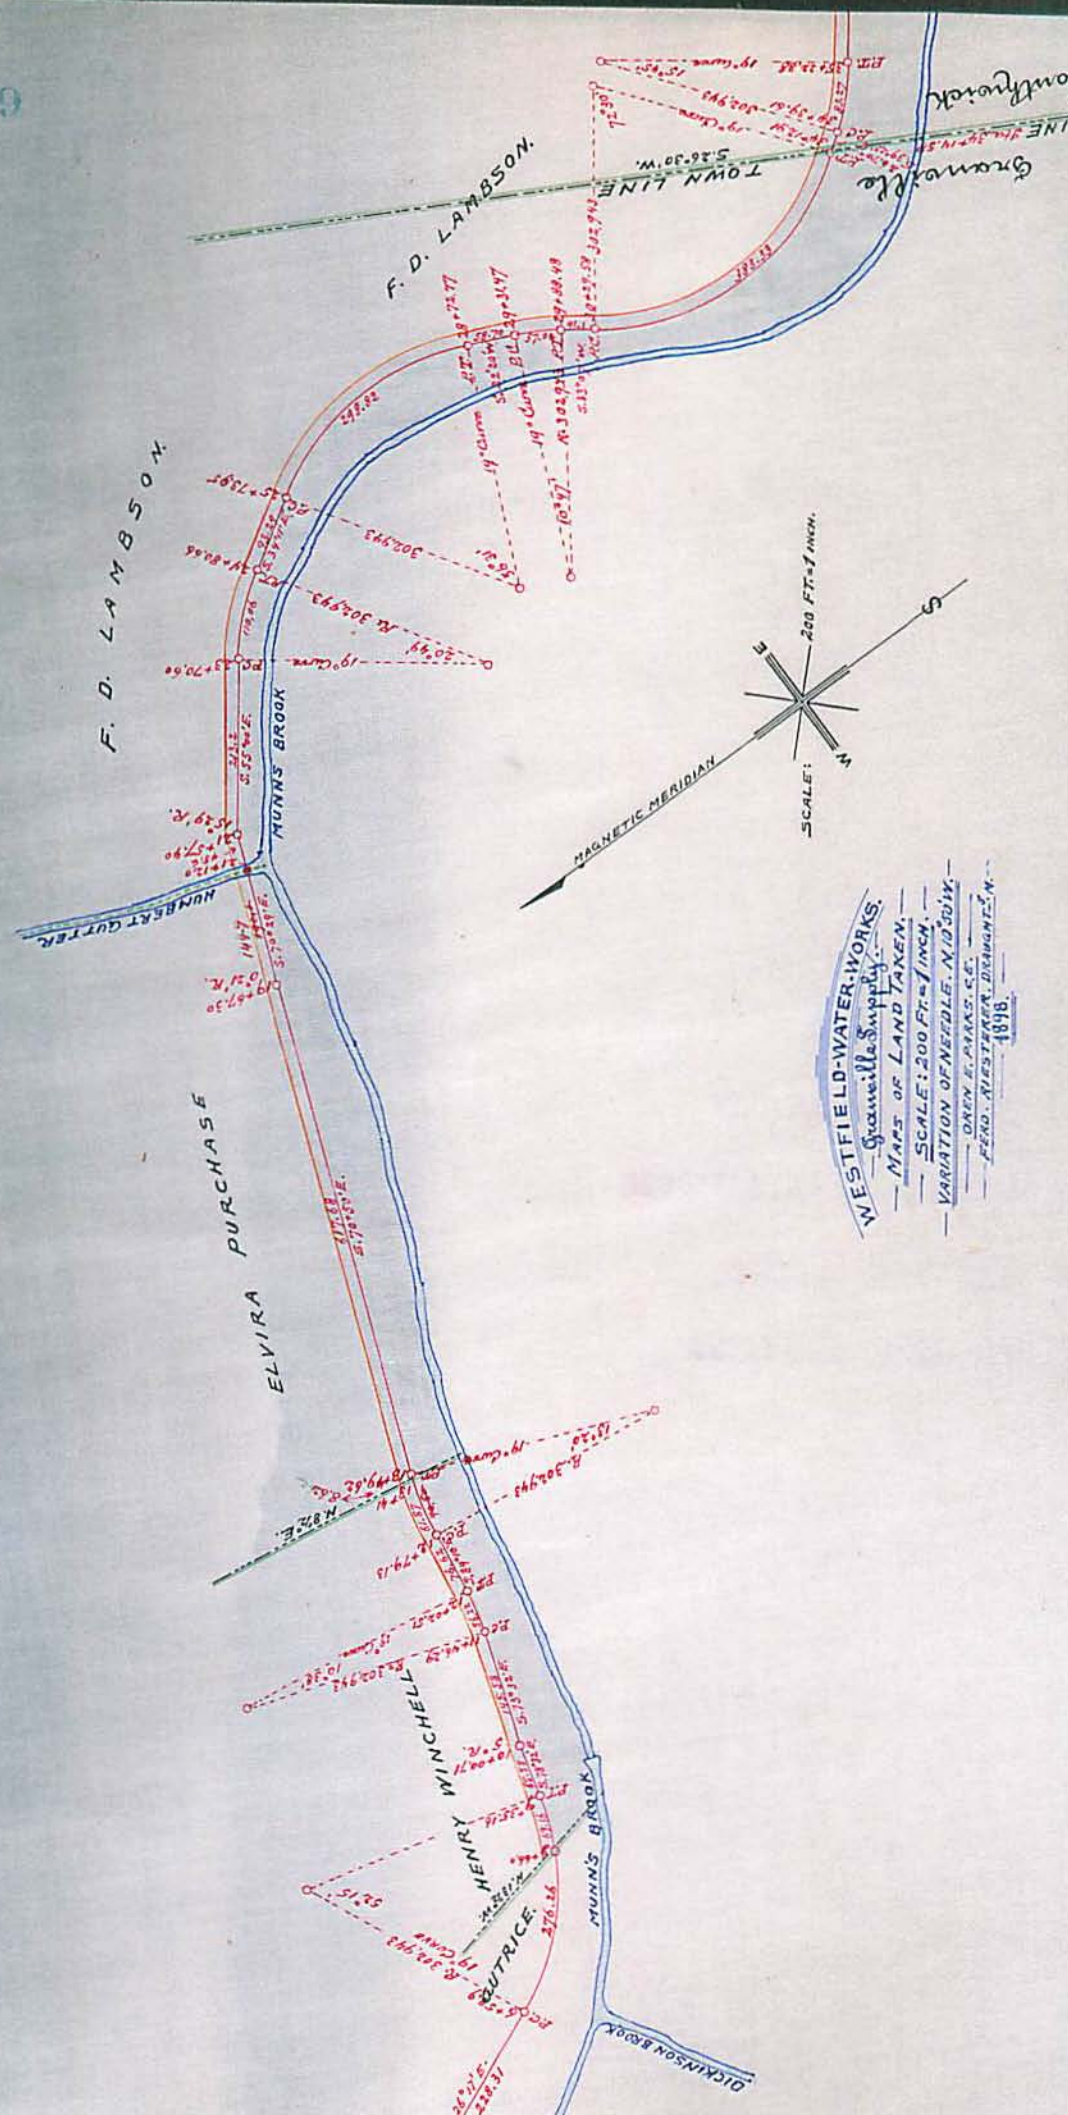
WESTFIELD-WATER-WORKS.
Granville Supply.
— MAPS OF LAND TAKEN. —
— SCALE: 200 FT. = 1 INCH. —
— VARIATION OF NEEDLE, N. 10° 30' W. —
— DRAWN BY P. A. S. C. E. —
— FIELD, WESTERN, DRAINAGE, N. —
— 1898.

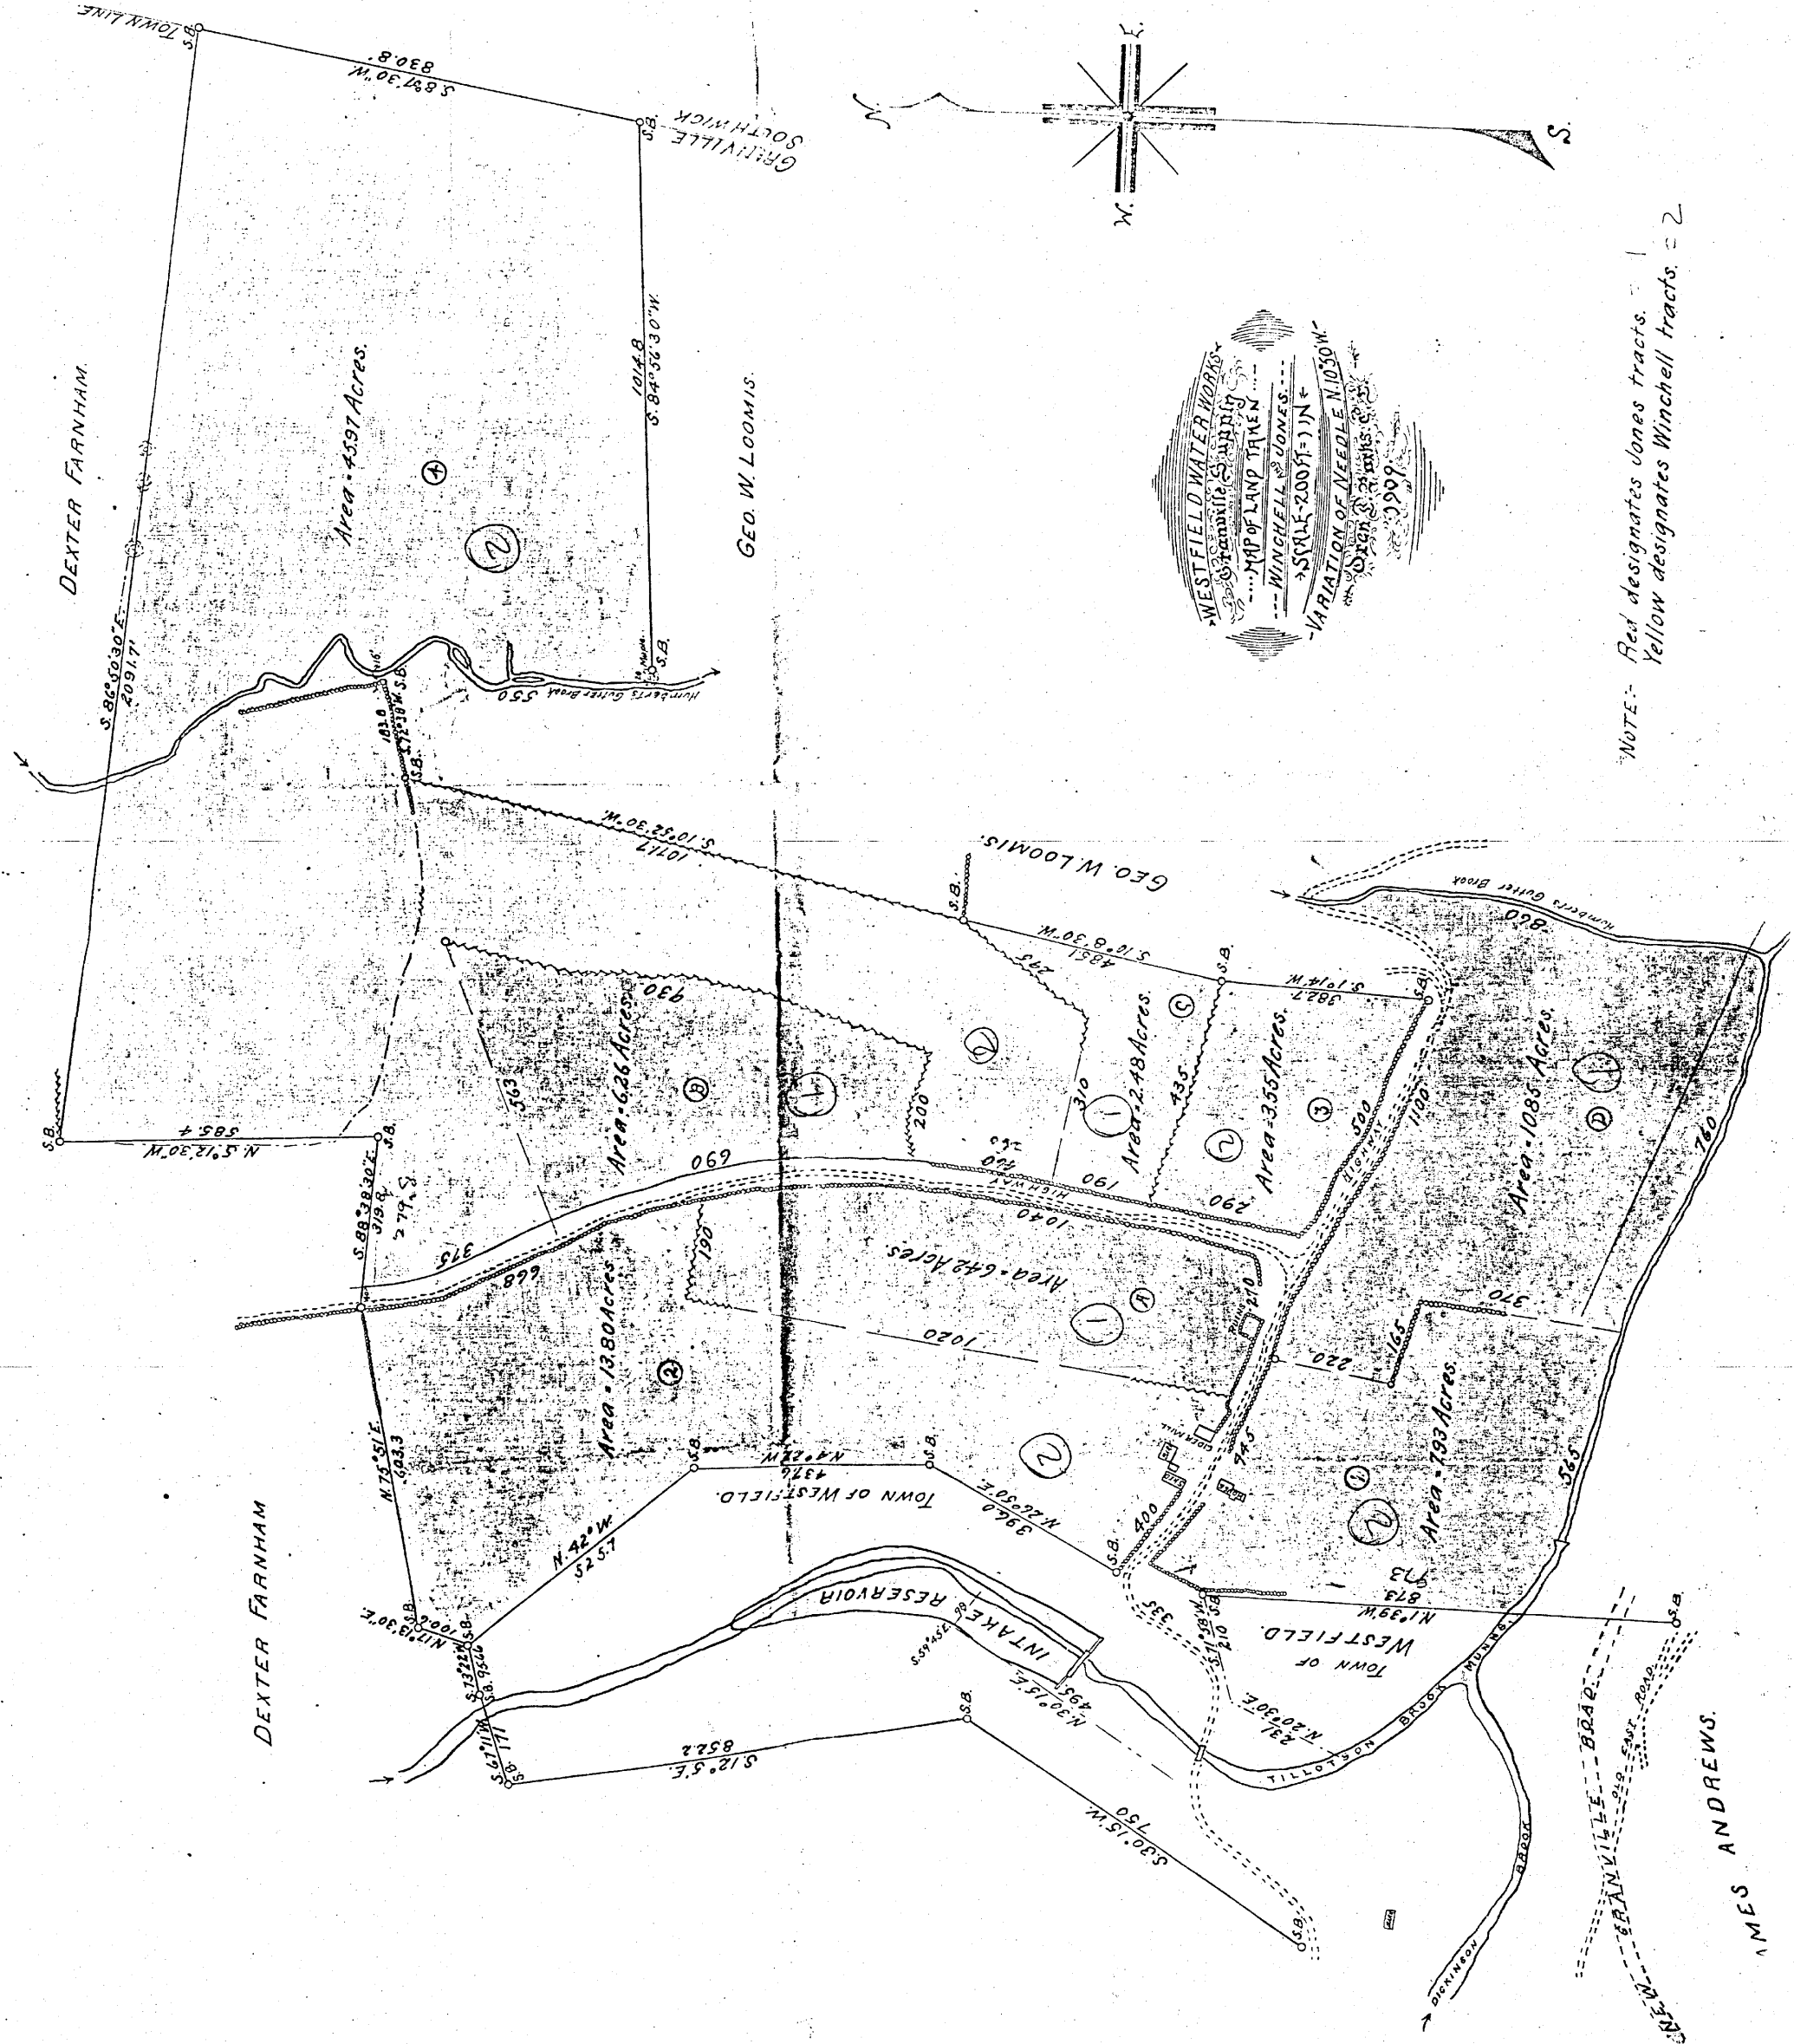
WESTFIELD WATER WORKS
TAMMIS S. W. JONES
MAP OF LAND TAKEN
WINCHELL S. JONES
SCALE 200 FT. = 1 IN.
VARIATION OF NEEDLE N. 10° 30' W.
1909

NOTE:- Red designates Jones tracts.
Yellow designates Winchell tracts. = 2

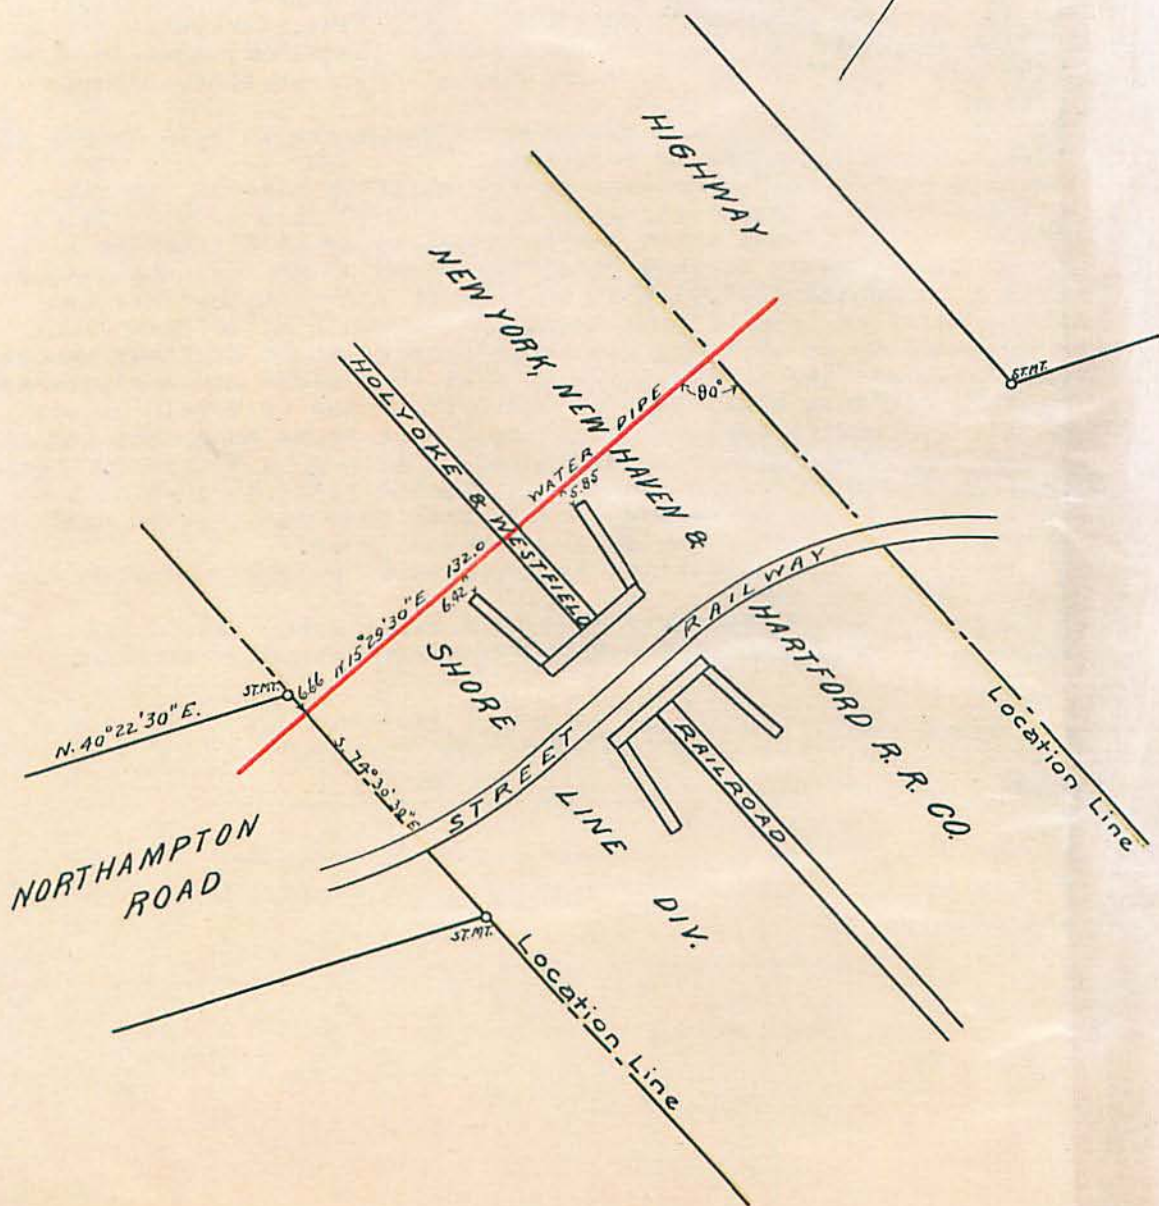
- MAP OF TAKING
- N.Y. N. H. & H. R.R. CO. -
- SCALE: 1 INCH = 40 FEET -
- ORENE PARKS - C.E. -
- 1909. -

Now, therefore, Know All Men By These Presents, that the said Town of Westfield, by virtue of, and in the exercise of, and in part execution of the powers conferred by said Act, for the purpose of distributing such waters and for effectually carrying out the provisions of said Act, has, on this twenty-ninth day of October, in the year nineteen hundred and nine, taken the right to lay down, carry and maintain water pipe through, under and across the location of the Holyoke and Westfield Branch of the New York, New Haven & Hartford Railroad Co. along the following described line:-
